TECHNICAL REPORT

INVESTIGATION ON THE PRESENCE OF DETACHMENTS OF GLAZED CERAMIC TILE PANELS BY MEANS OF NON DESTRUCTIVE ACOUSTIC MAPPING

Paola Calicchia
(CNR_IA)

Joao Manuel Mimoso
(LNEC)

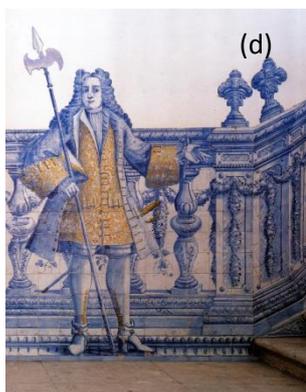
Fig. 1: Integration of glazed tile ornamental coverings into architectural structures.

Later in the century a new fad by which domains were populated by azulejo personae and animals spread and rooted. The aristocracy populated the stairs of their palaces with make-believe armed guards or servants inviting guests in (Fig.1 d Paço dos Arcebispos, Santo Antão do Tojal). Children and animals observed from behind stair balusters (all painted in tile panels) while simulated street goers peeped to gardens from closed barred gates. The inextricability of Portuguese azulejos and architecture is nowhere more evident than in this trompe l'oeil world [4].

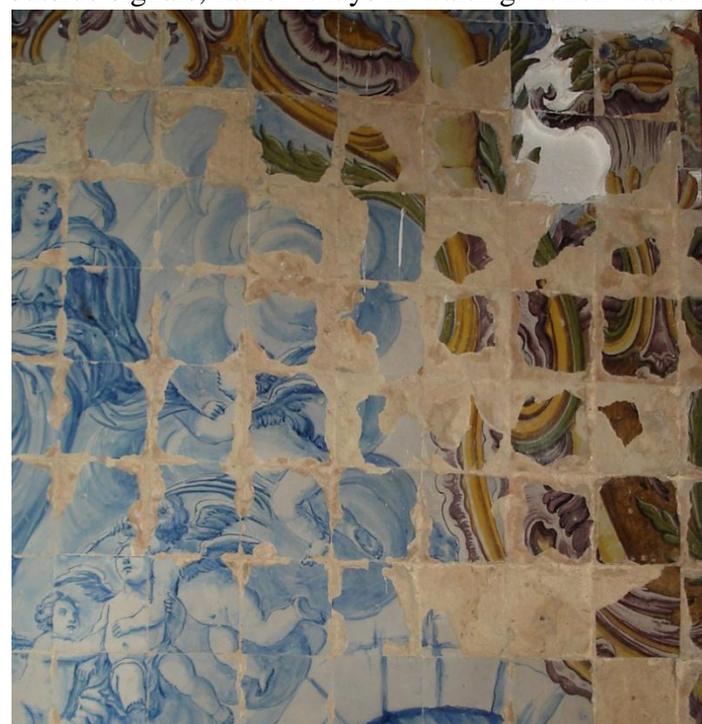
Fig.3: Generalized decay of an interior panel (Igreja de Jesus, Setúbal).

open spaces under the glaze resulting from delamination, causing a characteristic bubble that breaks away leaving a lacuna wherefrom the process of detachment later progresses. Cases are found nowadays where well over a third of the glazed surface has been lost [1] in a decay process that is in progression and will inevitably lead to the loss of whole panels of heritage value (Fig.3).

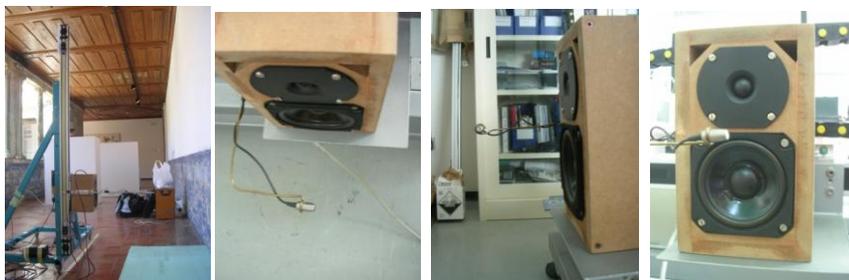
Fig. 6: The ACEADD system illustrating the linear scan unit and the transmit-receiving unit.

The system employed in this work is the CNR_IA laboratory prototype equipped, in this case, with the Linear Scan Unit LSU, suitable for many different configurations of the site. The Transmit-Receiving Unit TRU is composed of a full range acoustic source S and an omnidirectional receiver M mounted in a co-axial configuration and placed at normal incidence with respect to the surface. Standard working distance was set to about 40cm from the surface (Fig.6).
