SLAPIS
Système Local d'Alerte Précoce
pour les Inondations de la Sirba

Mapping of the flooded areas of Niamey following the flood of the Niger River in August-September 2020

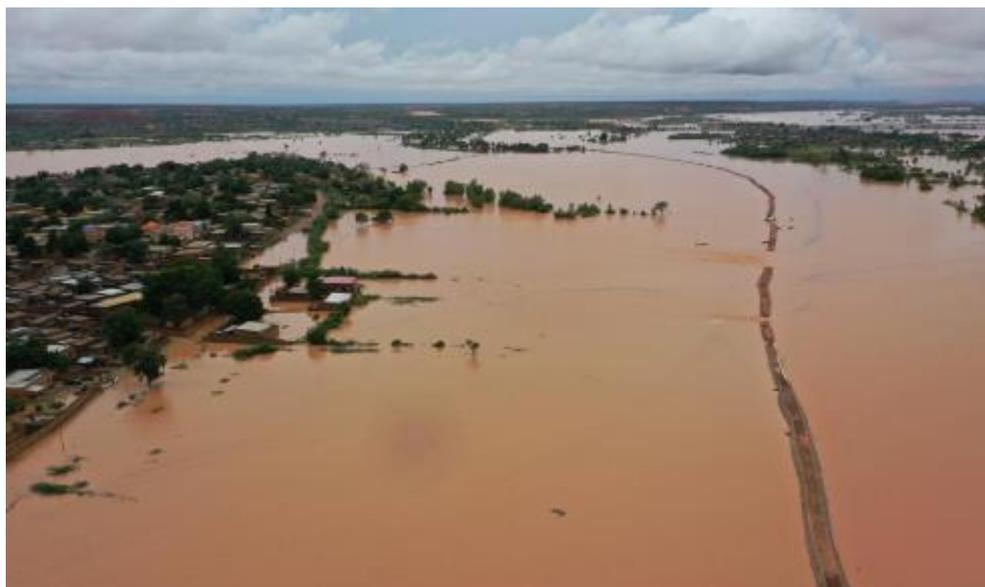
Figure 1, Aerial view of Lamordé dike

On September 6 at 7 a.m., the Niger River reached a new peak never reached at 680 cm following heavy precipitations in Niamey and in the upstream sub-basins. The Lamordé dike, which had been raised, ended up giving way and the districts of Lamordé, Zamargandey, Karadjé and the low areas on the right bank of the river were completely inundated as well as the districts of Gamkalley and Saga on the left bank. The populations evacuated the flooded neighborhoods. EMIG (School of Mines, Industries and Geology) and Lamordé Hospital (CHU) were also flooded.

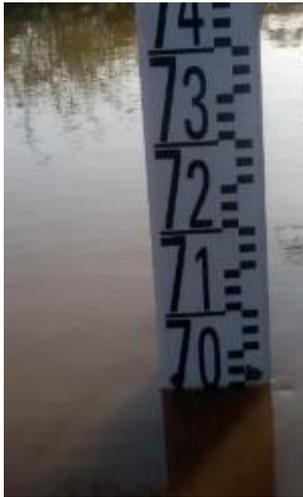
Figure 2, Niamey limnometric scale on September 8, 2020 at 7 a.m.

It should be noted that the Niger River, on September 8, 2020 at 7 a.m., reached the highest level since the creation of the Niamey measuring station in 1929, i.e. 700 cm, and well 62 cm more than the record of September 1, 2019 at 638 cm.

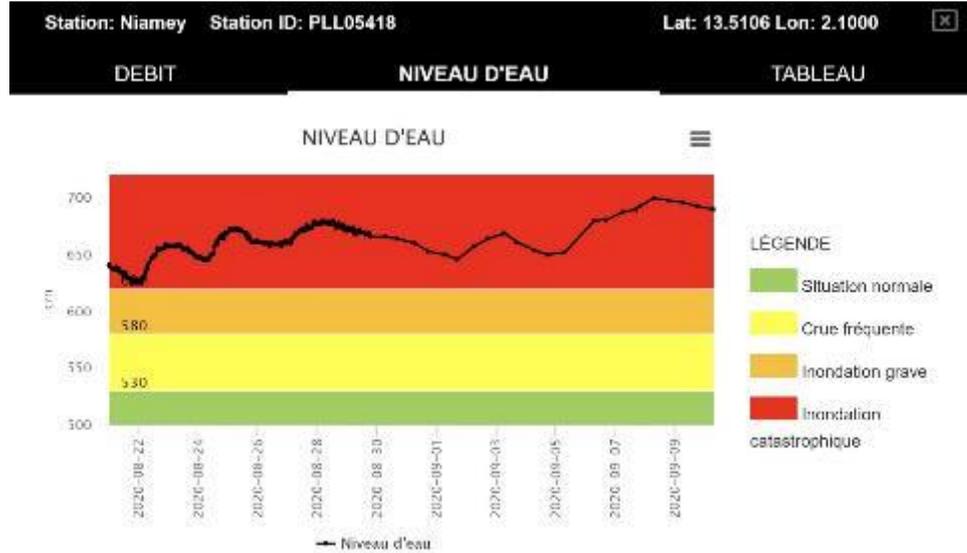
Figure 3, Hydrograph of the Niamey station and alert thresholds (since August 29 the automatic hydrometer has been flooded and the measurements are manual)

The 2020 “red” flood is by far the most intense on record. It is either very early either exceptional in terms of recorded heights due to the very intense precipitation observed this year and also to the gradual silting up of the river bed, which at equal flow increases the water level.

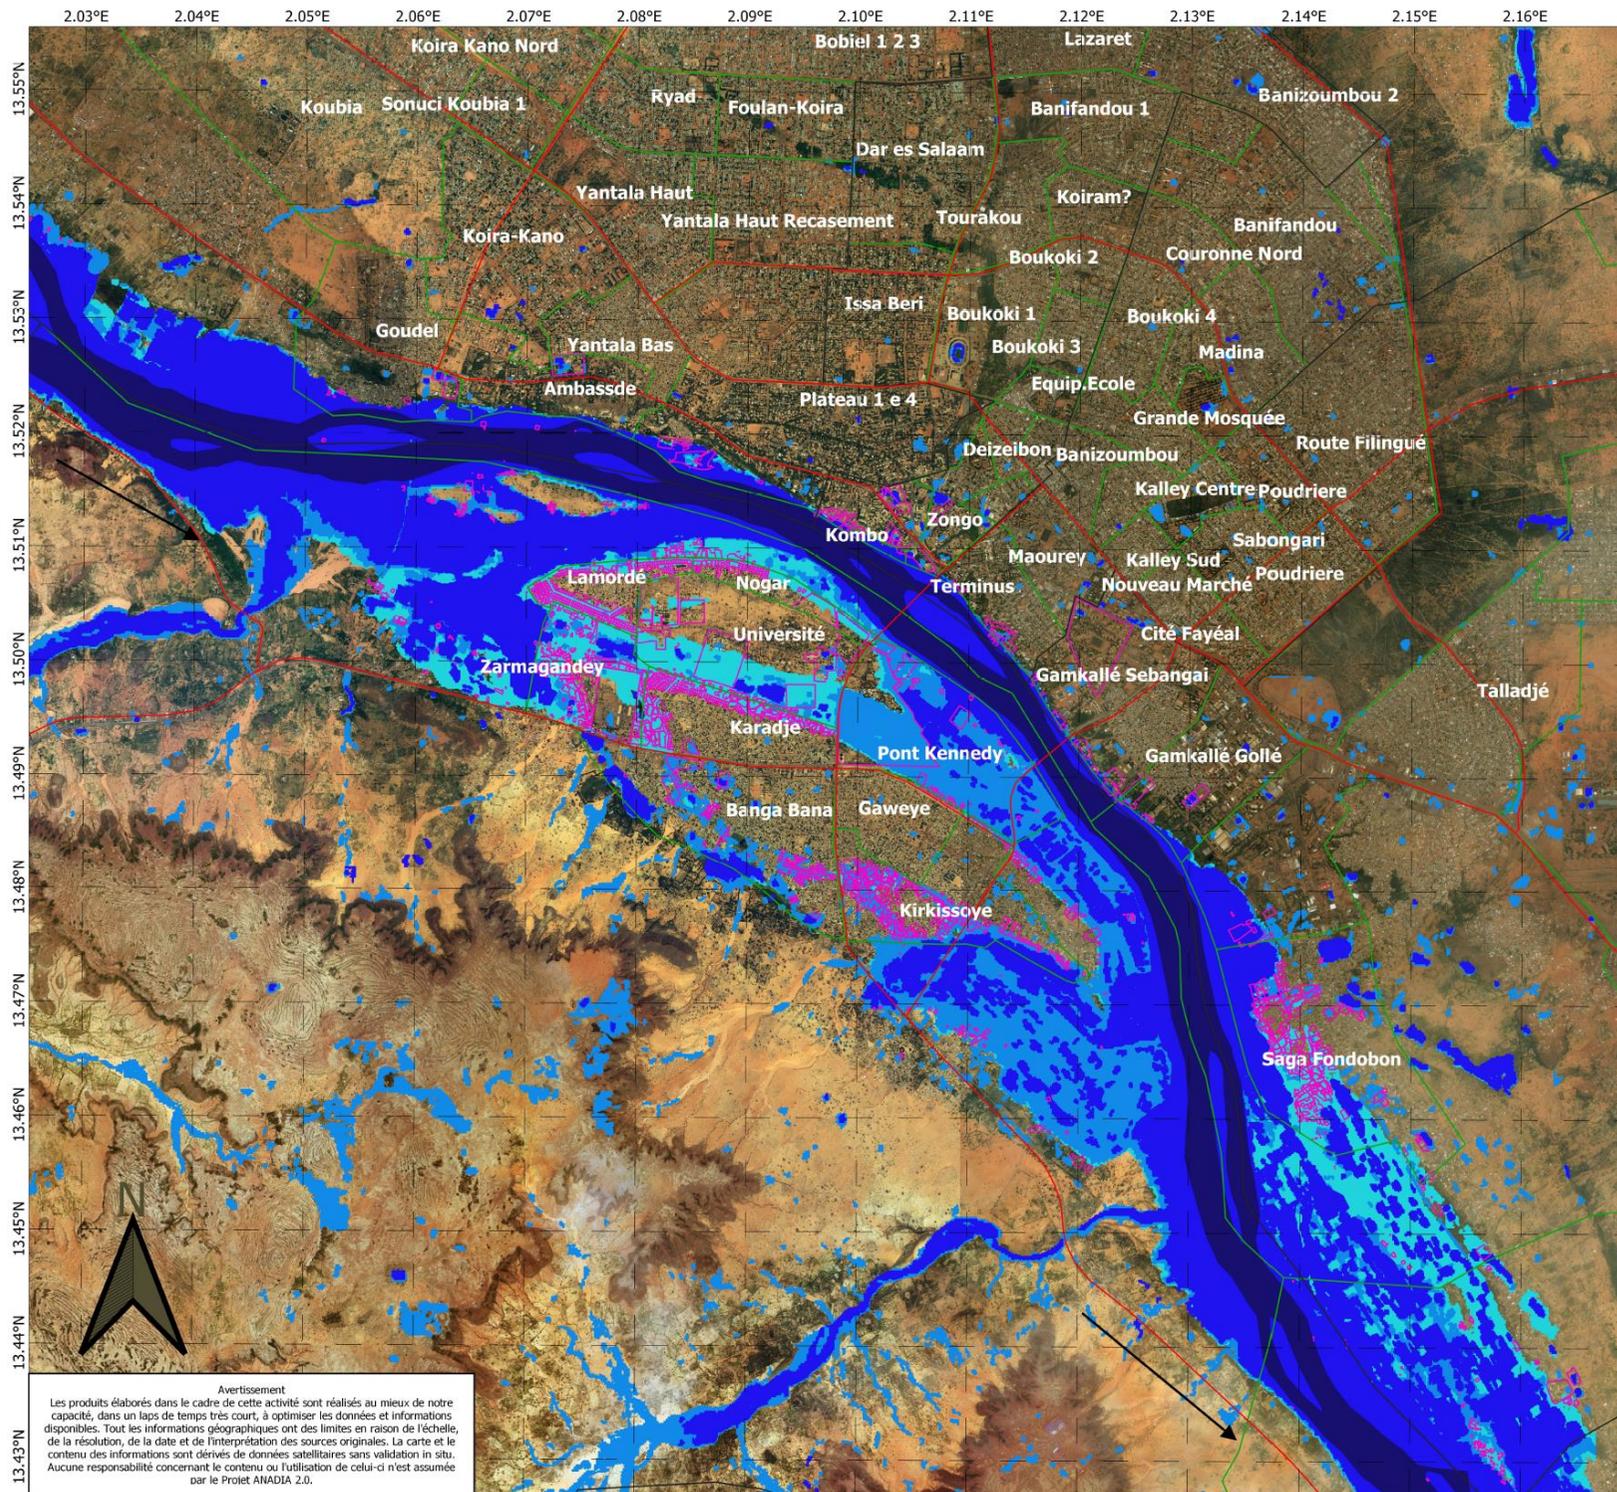
Carte des zones inondées Ville de Niamey (Niger) Fleuve Niger - crue 2020

The flooded area map presented below has been developed from Sentinel 2 satellite images at a resolution of 10 meters acquired on the dates of August 16, September 5 and September 10, 2020. The classification of the flooded areas was carried out using the NDFI index (Normalized Difference Flooding Index)¹.

V.Tarchiani, G. Massazza, E. Fiorillo et S. Braccio
 Système de référence: ellipsoïde WGS 84
 Orthophotos: Bing Satellite, Microsoft C. 2019, D.G.D.A. DS
 L'identification des zones inondées a été réalisée en utilisant images Sentinel 2 (10x10 m) du 16 août et du 5 septembre 2020 et l'indice NDFI (Normalized Difference Flooding Index).
