# PAST AND PRESENT OF THE EARTHEN ARCHITECTURES IN CHINA AND ITALY

EDITED BY  
LOREDANA LUVIDI, FABIO FRATINI  
SILVIA RESCIC AND JINFENG ZHANG

This series of volumes comprises research outputs that have been achieved due to the financial contribution of the National Research Council of Italy (CNR) and the the Chinese Academy of Cultural Heritage (CACH) within the context of a Bilateral Agreement of Scientific and Technological Cooperation between these two Institutions.

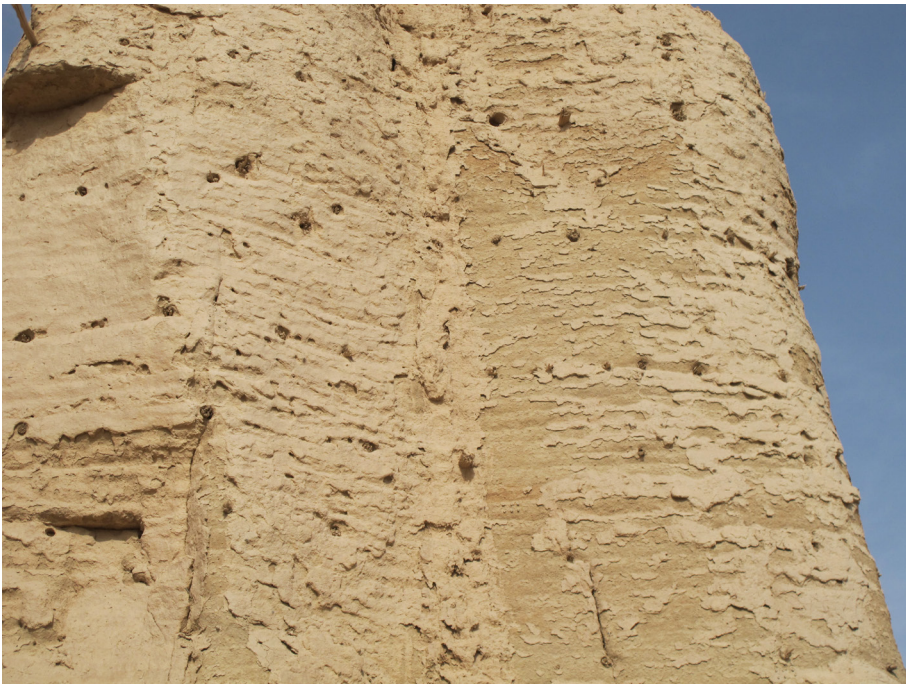
Spalling is a process in which the surface of an earthen site suffers pressure from external or internal forces, which results in a layer of crust peeling off in sheets or small blocks. The external or internal forces that lead to this phenomenology can be rain, wind, temperature or crack. The first two factors are very common in earthen sites in arid areas of northwest China.

Fig. 2 Spalling decay effect on a wall

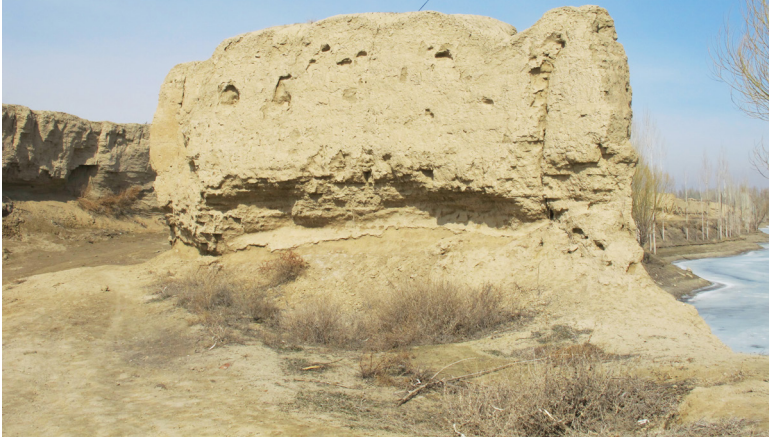
Erosion refers to the loss of earth to a certain depth, under the action of wind, rain, water and salt crystallization. It is a typical decay in the arid regions of northwest China.

Fig. 3 Erosion deterioration

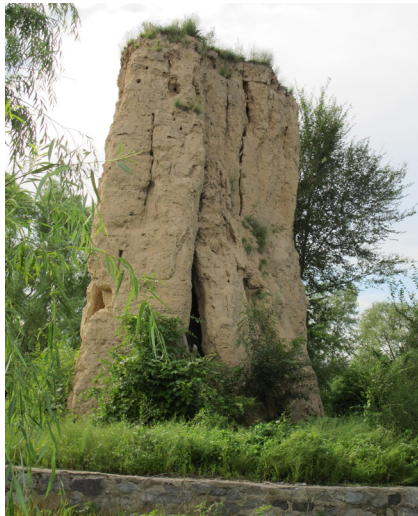
Fissures can develop due to different causes such as unloading fissures, structural joints, deformation fissures and manufacturing fissures. They often started the process of collapse.

Fig. 4 Fissure deterioration

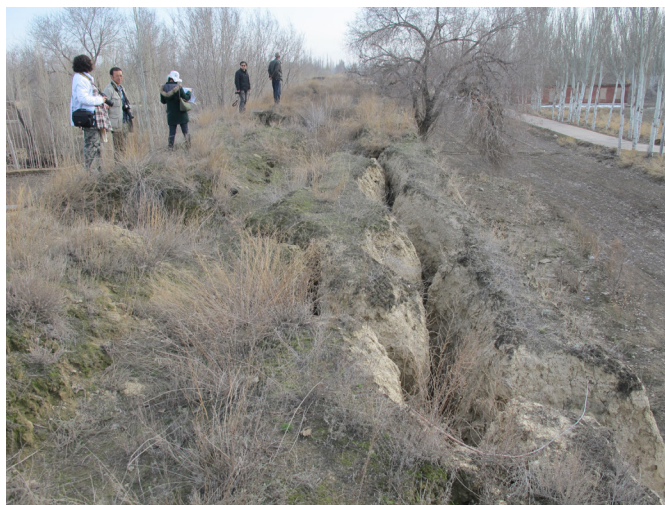
Gully are formed through surface runoff generated by rainfall especially in the proximity of reliefs (Zhao et al., 2003). Fissure gullies and runoff gullies can be recognised.

Fig. 5 Gully deterioration

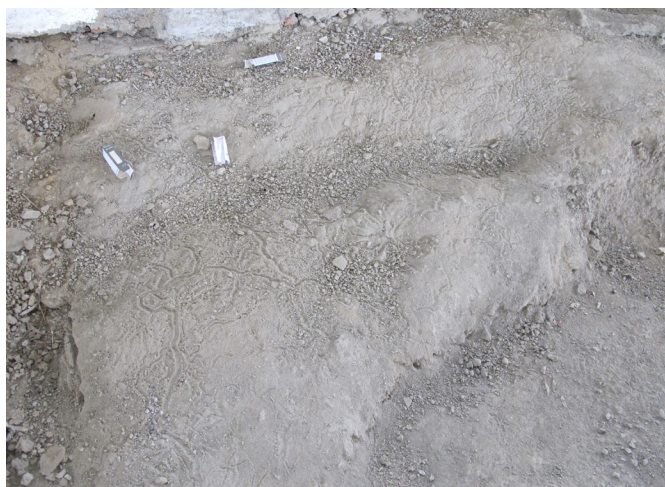
Pulverization is caused by periodic changes in the temperature and humidity, freezing and thawing or salt crystallizations.

Fig. 6 Pulverization decay effect

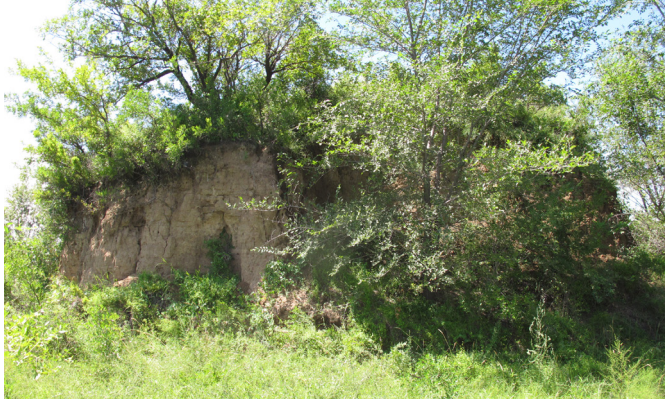
Biological damage is caused by the actions of animals or plants present around earthen sites.

Fig. 7 Biological damage caused by plant growth on earth sites

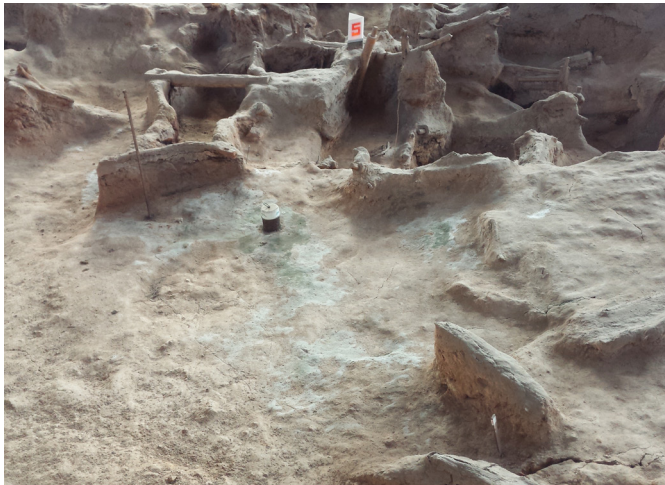
The decay due to microorganisms can cause serious damage to earthen sites. Some bacteria and molds can produce organic acids that directly decompose organic and inorganic matter in the earth causing powdering and flaking. In addition, some molds can secrete pigments which can adhere to the surface of cultural relics, and affect the appearance of earthen sites.

Fig. 8 Deterioration due to the growth of microorganisms: color variations, powdering and flaking

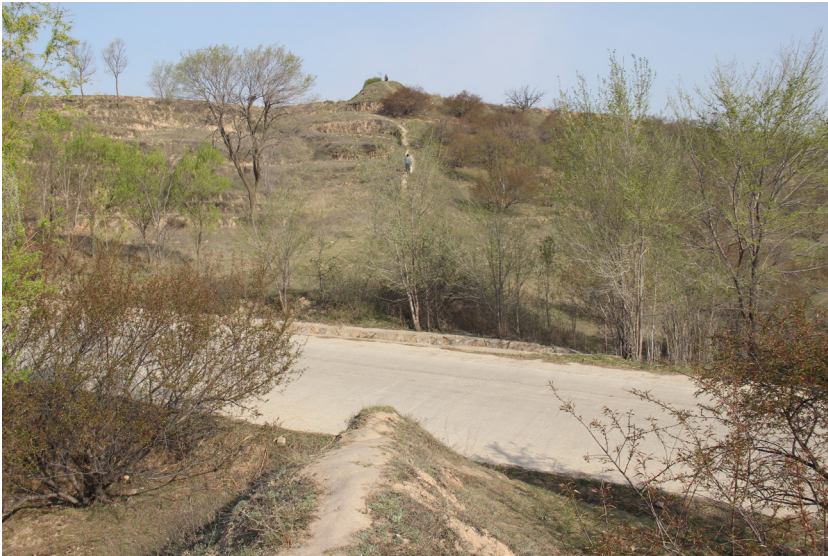
Modern destruction refers to the destruction of earthen sites caused by modern human activities. The forms and contents of modern destruction are complex and varied, such as industrial construction, agricultural farming, soil collection, houses building, roads building and water carriage system construction.

Fig. 9 An example of modern destruction, the Great Wall cut into two sections by a road

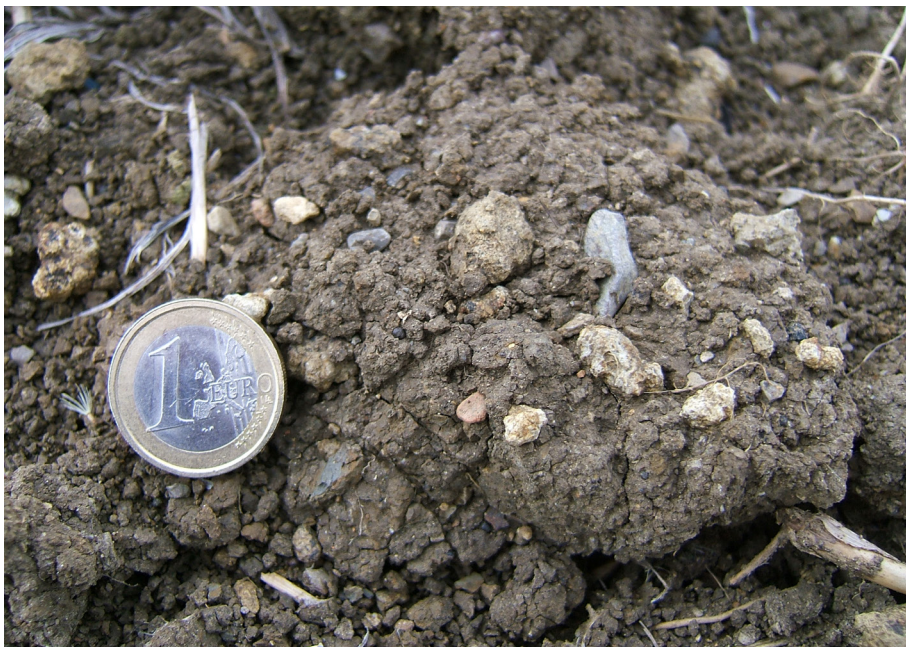
The mineral component of an earth consists of a fine-grained fraction mainly composed of *clay minerals* belonging to the Phyllosilicates class (which dimension is below  $4\ \mu\text{m}$ ) and a coarse-grained fraction (silt, sand and gravel fractions) composed of quartz, feldspars, carbonate, iron hydroxides and rock fragments (Fig. 1).

Fig. 1 Particular of an earth, it is possible to recognize the different grain fraction and the organic component

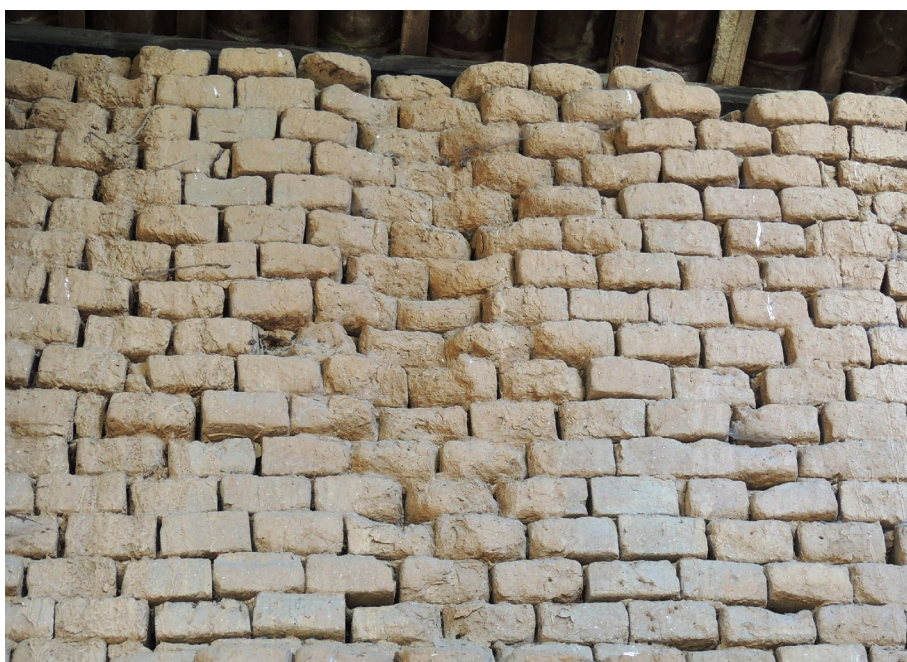
Fig. 4 Rain erosion of an adobe masonry in Piedmont (Italy) due to lack of maintenance of the roof

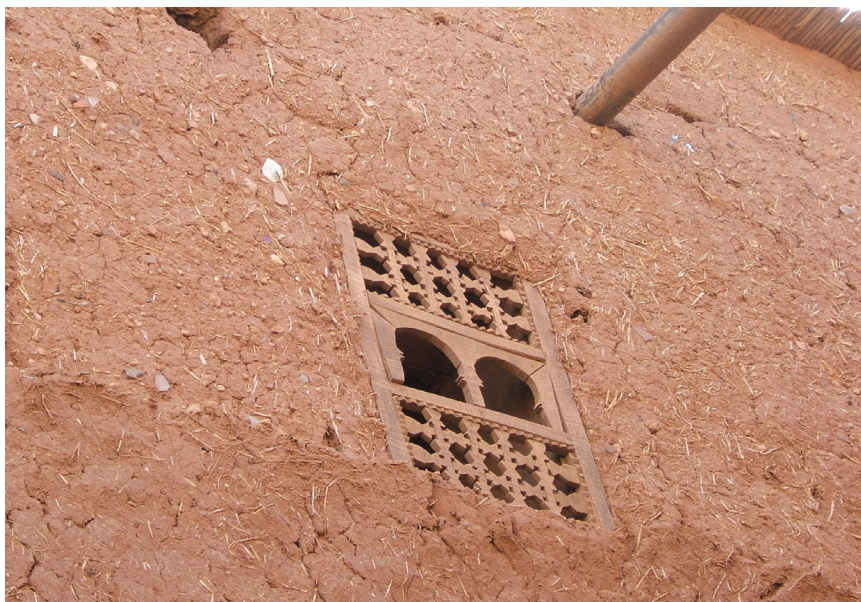
Fig. 6 Earthen plaster added with vegetable fibers to avoid shrinkage fractures (Morocco)

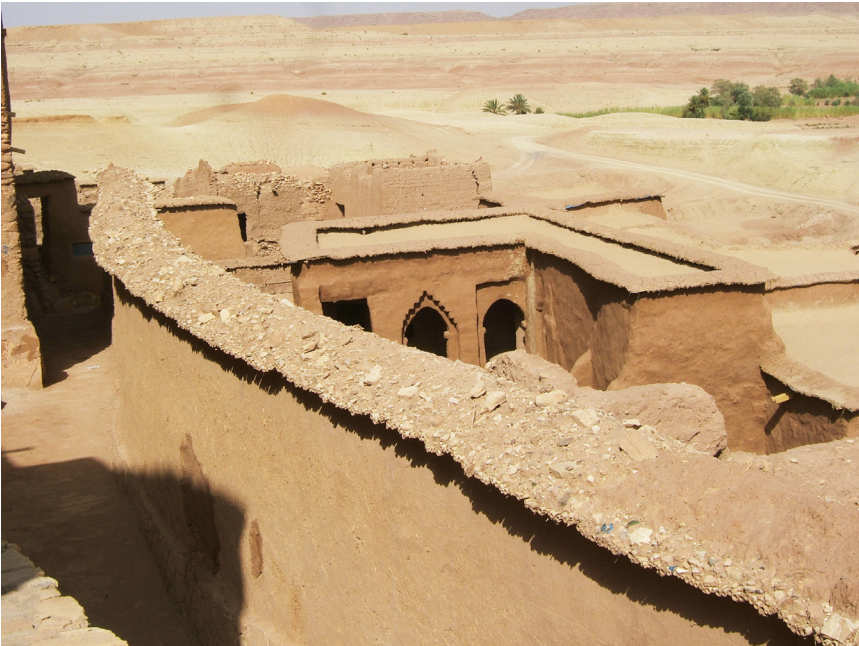
Fig. 9 Protection of the ridge of the walls to avoid water infiltration (Morocco)

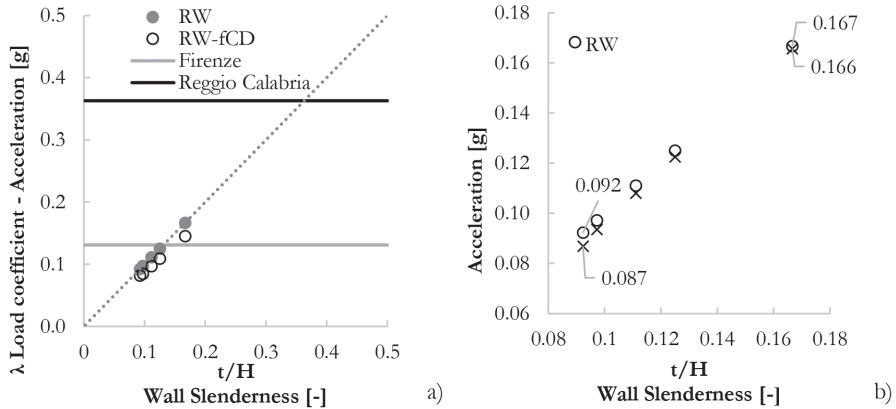
For a configuration of the slab on the 4 x 4 m masonry cell where main beams rest on the overturning wall, Fig. 3b shows the values of the activation acceleration of the mechanisms, RW-P2, compared to those of the overturning rigid wall, RW. Looking at Fig. 3b it can be noted that the superimposed slab force P2 affects slender walls more than stockier. Owing to superimposed loads, the value of the activation acceleration decreases, with respect to that of the simple rigid wall, by 5.4% and 0.6% respectively for the slenderest and stockiest profiles.

Fig. 3 a) Load coefficient values, coincident with the activation acceleration, for the overturning rigid wall (RW) and assuming a limited compressive strength  $f_{cd}=0.56\text{MPa}$  (RW-f<sub>CD</sub>) superposed to the expected peak ground accelerations in Firenze and Reggio Calabria (Italy). b) Activation acceleration values of an overturning rigid wall (RW) and for the same wall bearing an over load P2=28KN (RW-P2)

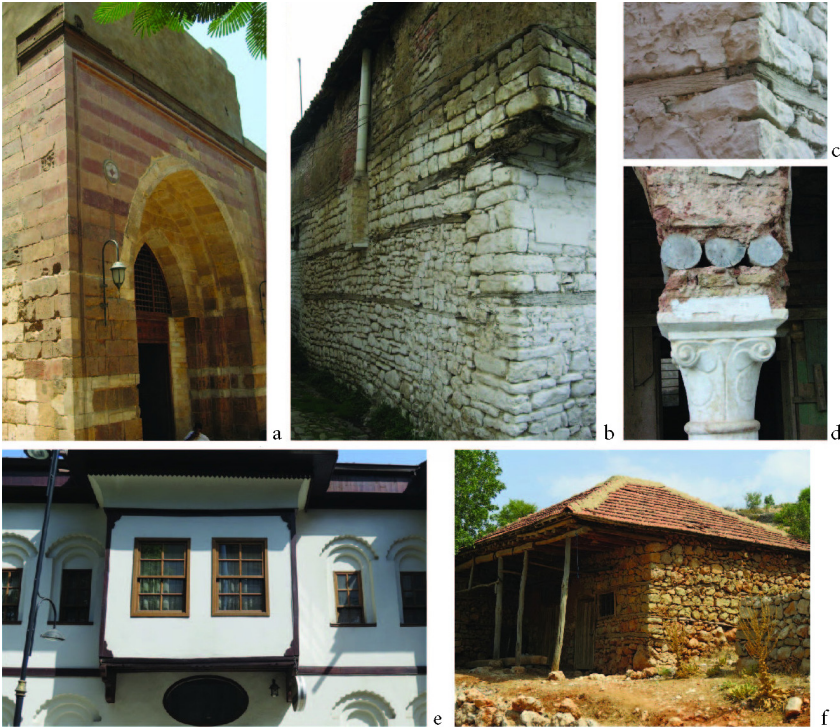
Fig. 4 Examples of anti-seismic and traditional retrofitting techniques making use of timber: a) Bayt es-Suhaymi palace, Cairo, Egypt, XVII century; b) and c) The Kalà of Elbasan, Albania, XV century; d) detail of a capitol of the Dey Palace, Algiers, Algeria, XVI century; e) and f) Malatya, Turkey

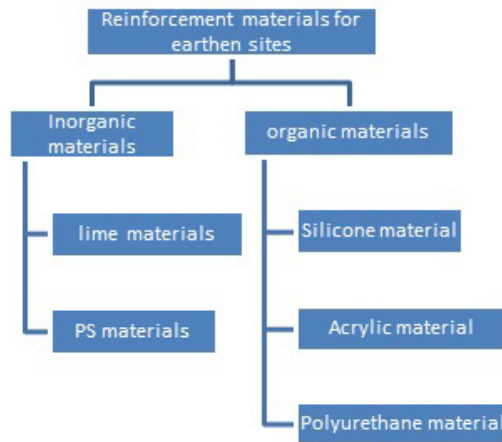
Fig. 4 Category of reinforcement materials for earthen sites conservation

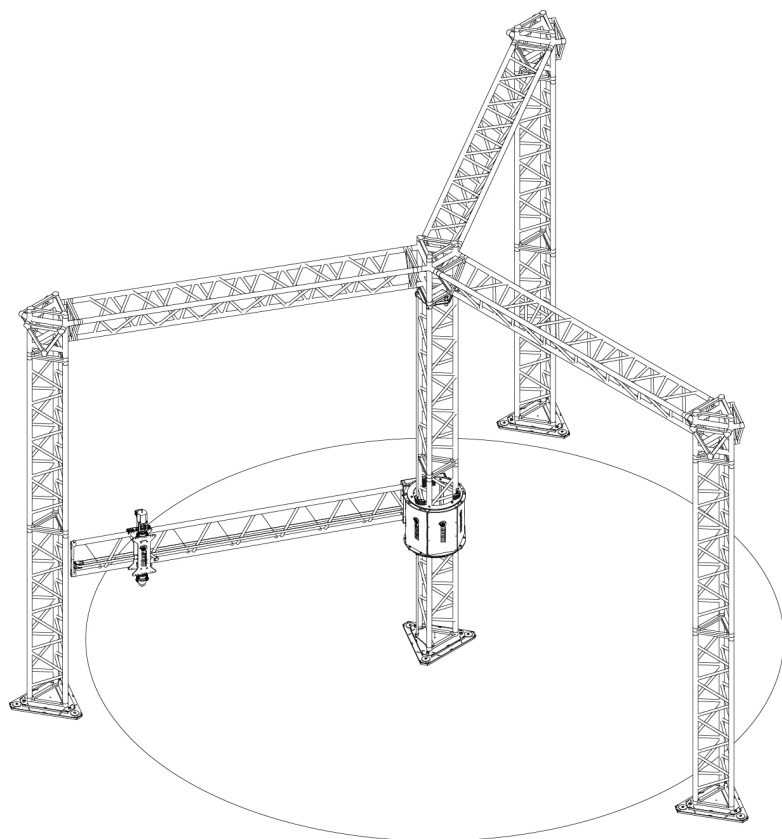
Fig. 2 Crane WASP, technical drawing by WASP, 2018

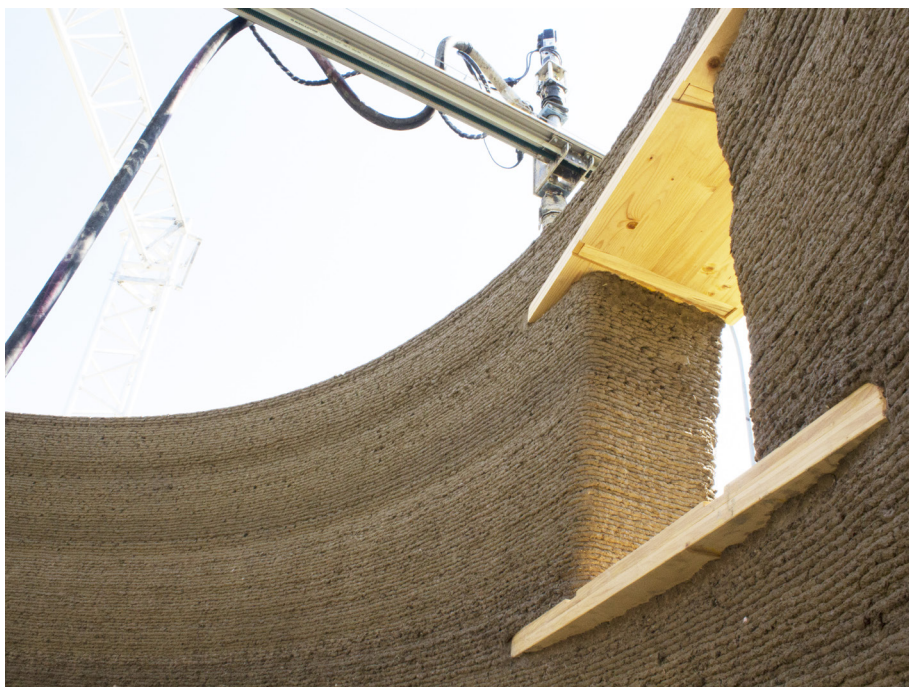
Fig. 4 Earthen mixture in 3D printing process, Gaia house, 2018

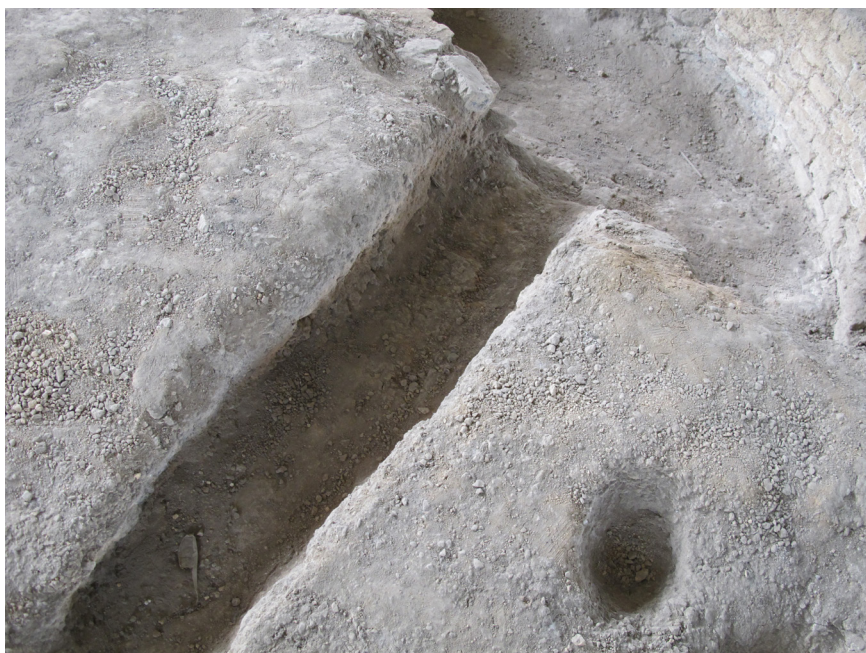
Fig. 2 Pulverization of the earth site: main phenomenon of surface decay

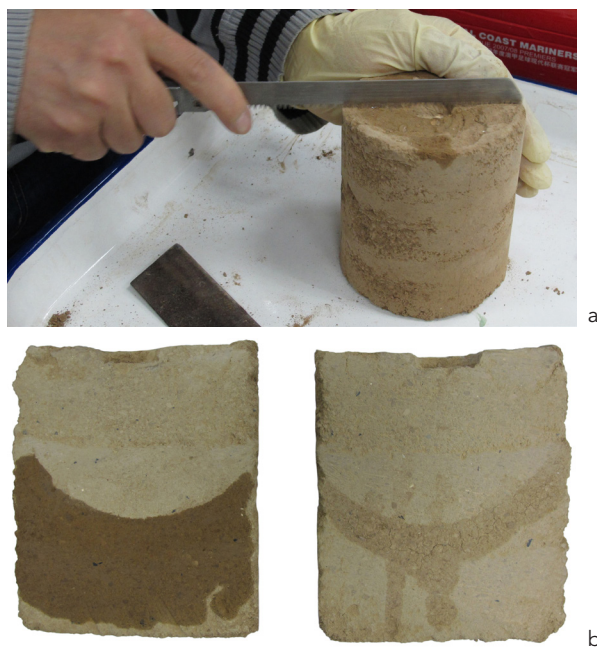
Fig. 3 Earthen samples ( $\varnothing 100$  mm  $\times$  120 mm) made for the measurements of the treatment depth: a) earthen samples cut into two halves; b) some water is put in one half the upper dry part means that is consolidated, the lower wet part is unconsolidated (left). The right image is after water evaporation.

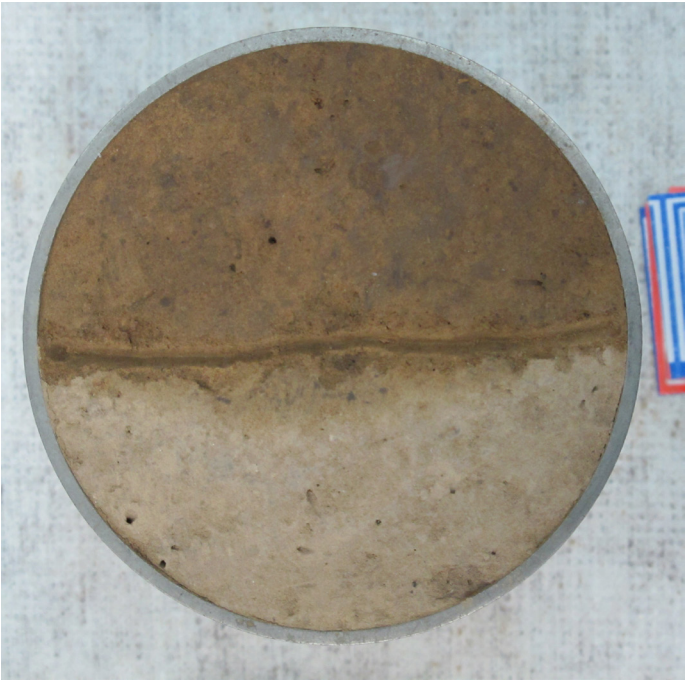
Fig. 5 Earthen samples are divided with a scored line and the consolidant is applied to one half. After curing of the consolidant, the colour difference between the two parts is evaluated to decide the gray scale rating

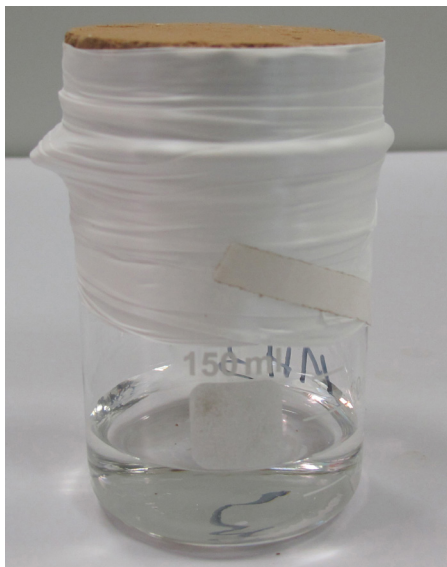
Fig. 6 Earthen samples were fixed on the top of cylindrical containers that are partially filled with water, sealed with a polytetrafluoroethylene tape, to evaluate the water vapour transmission

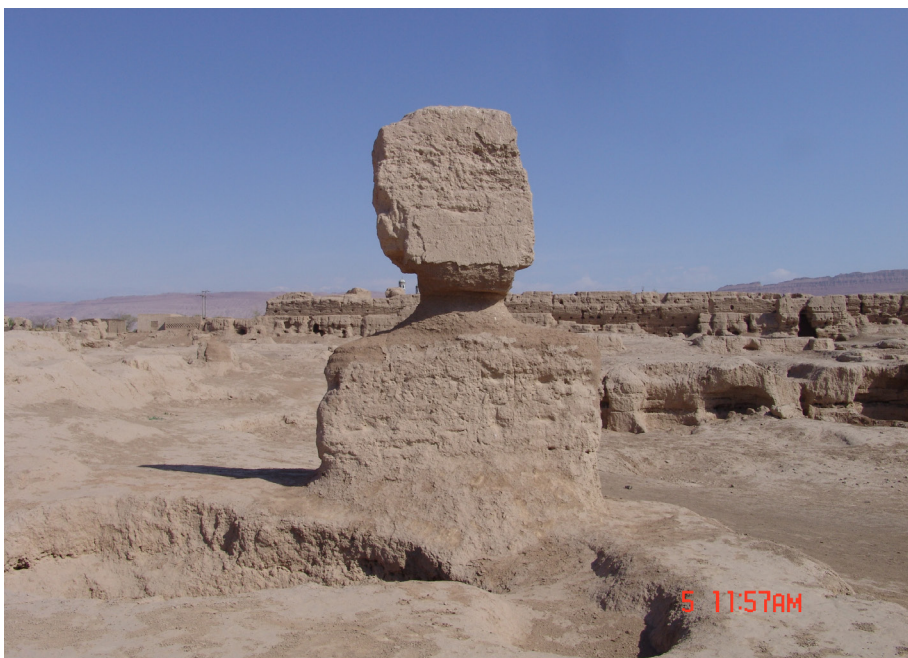
Fig. 3 Rammed earth wall eroded by winds

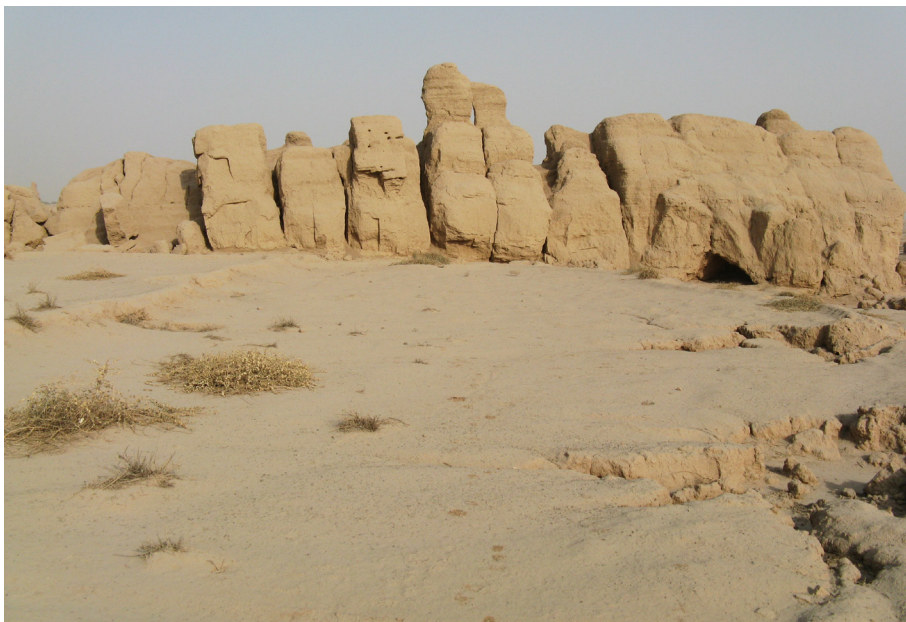
Fig. 4 Fissures on rammed earth walls

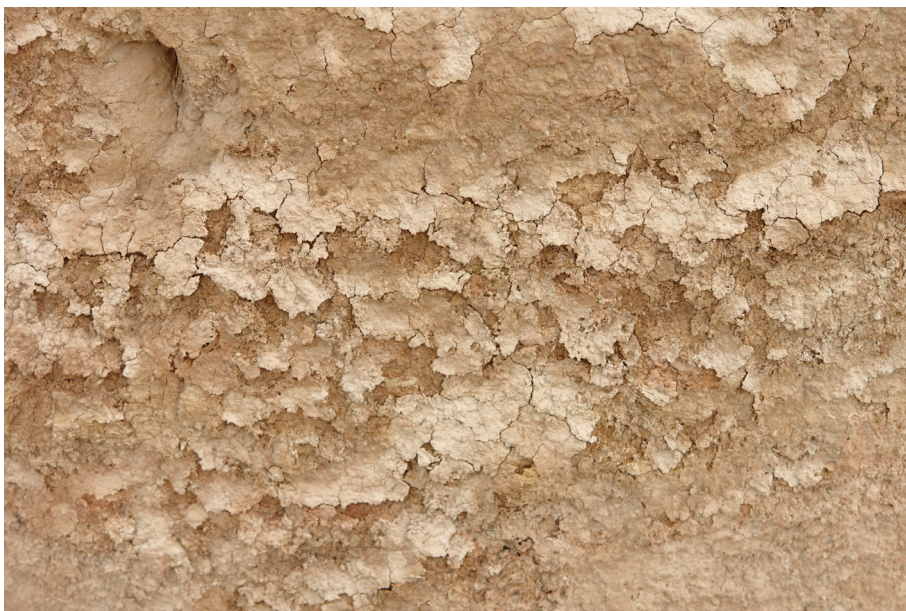
Fig. 5 Thin layer formed on the surface of an earthen wall after rain, subsequently cracked and about to fall

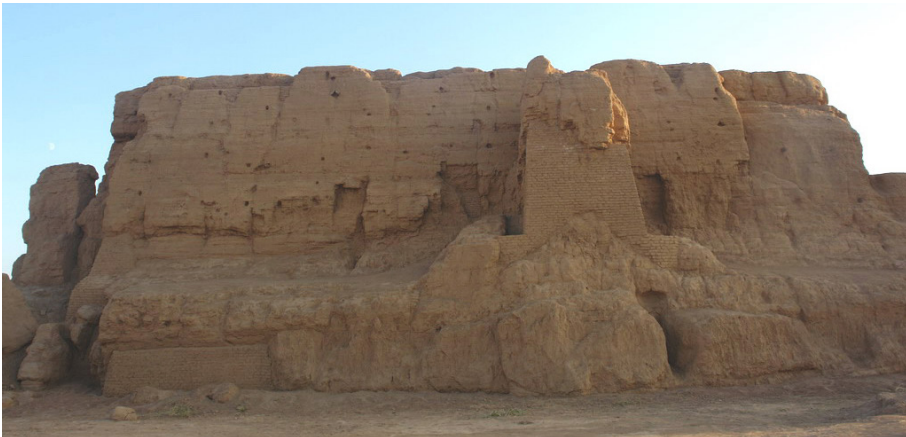
Fig. 8 General view of rammed earth walls after the construction of an adobe masonry support

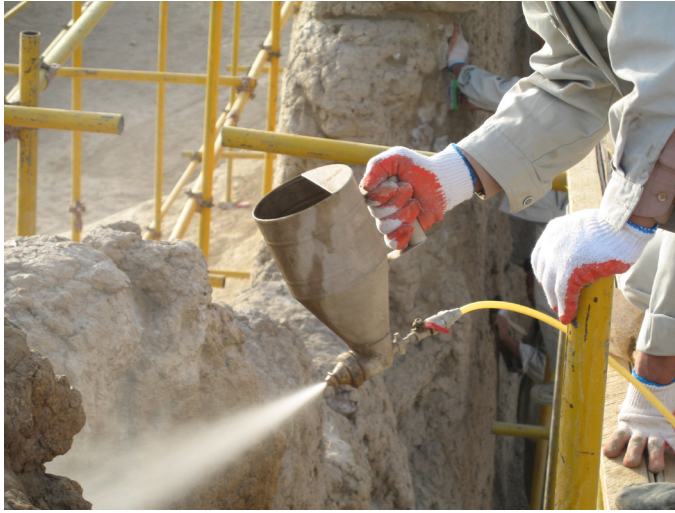
Fig. 10 Application of the consolidating product by spraying

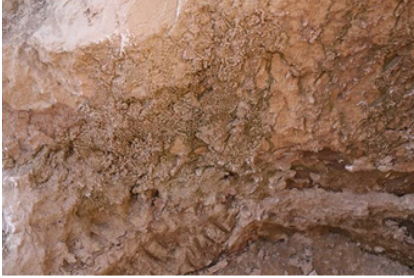
Fig. 1 Weathering of a southern surface of area F29 of the Lajia site

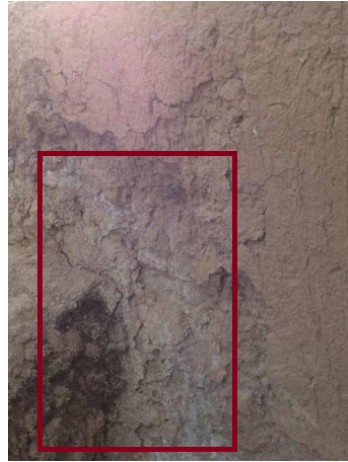
Fig. 4 Biodegradation caused by mould in area F29 (red square)

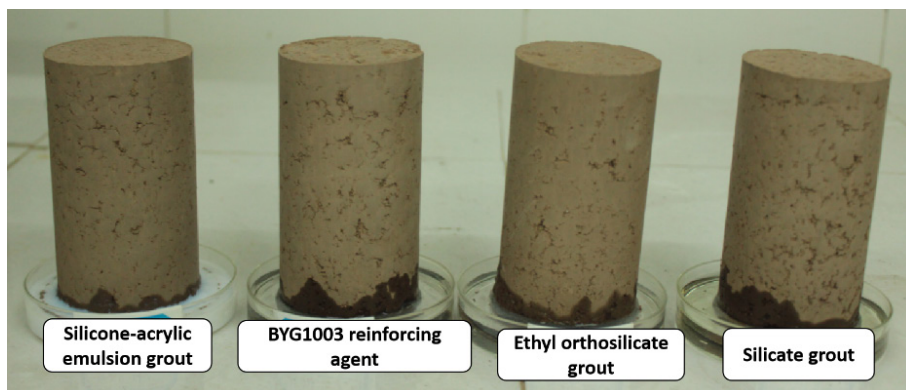
Fig. 7 Penetration depth test on cylindrical soil samples treated with four reinforcing materials

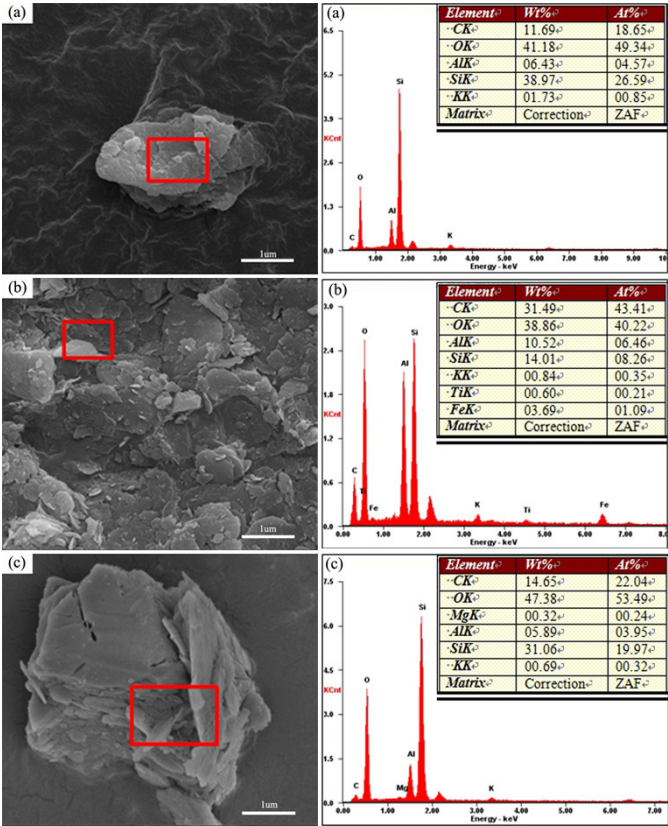
Fig. 2 SEM-EDX results of the three earthen samples; (a) 1# (earth inside the museum); (b) 2# (earth from the open-air); (c) 3# (earth from the ground surface)

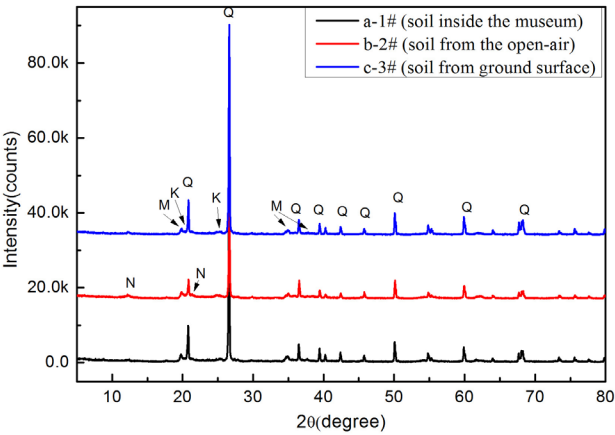
Fig. 3 XRD results of the earthen samples collected in the Tongguanyao site (Q-quartz, M-mica, K-kaolin, N-nacrite)
